# 平成 29 年 10 月 欧州砂防調査報告書

欧州砂防調査報告書

今回は、これらに引き続く一連の調査として、オーストリアでは 20 世紀初頭に BOKU 大学に留学した日本人研究者・技術者の軌跡をたどり、イタリアではフリウリ・ヴェネツィア・ジュリア州とトスカーナ州フィレンツェ近郊の砂防施設、土石流観測地及び災害現場の調査を行い、チェコでは諸戸博士アルバムの著書にある砂防工事個所調査を行い、フランスではサボア県の歴史的砂防施設の調査と RTM 実施本部訪問によるフランス砂防の情報収集を行った。

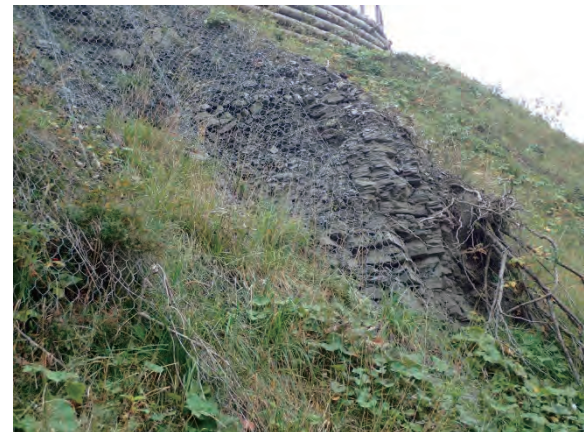
図 4.3-8 破碎された泥岩の露頭

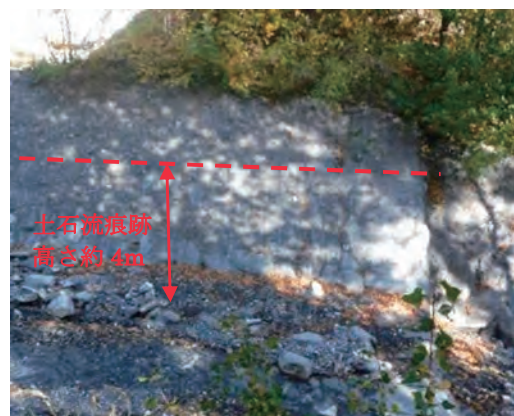
図 7.5-5 土石流痕跡

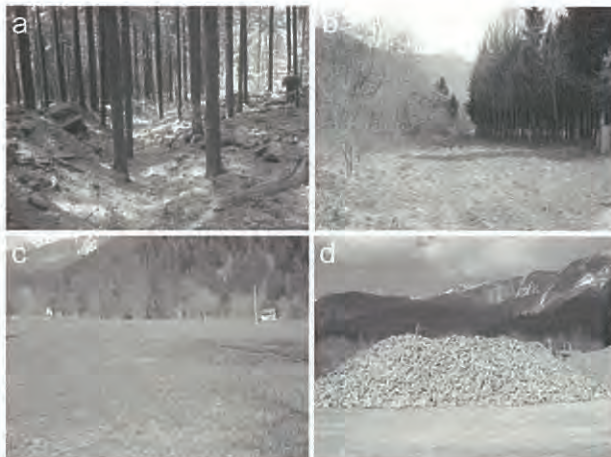
**Fig. 8.** Photographs of landforms related to the roughness index map (Fig. 7): (a) debris-flow deposits and levees, (b) a pipeline, (c) distal fan area with a smoothed surface, (d) quarry deposit.
