Actions for the Maintenance and Lifespan prolongation of SABO Facilities

Hisashi Watanabe^{1*}, Toshio Mori¹

¹ Sabo Frontier Foundation, Japan

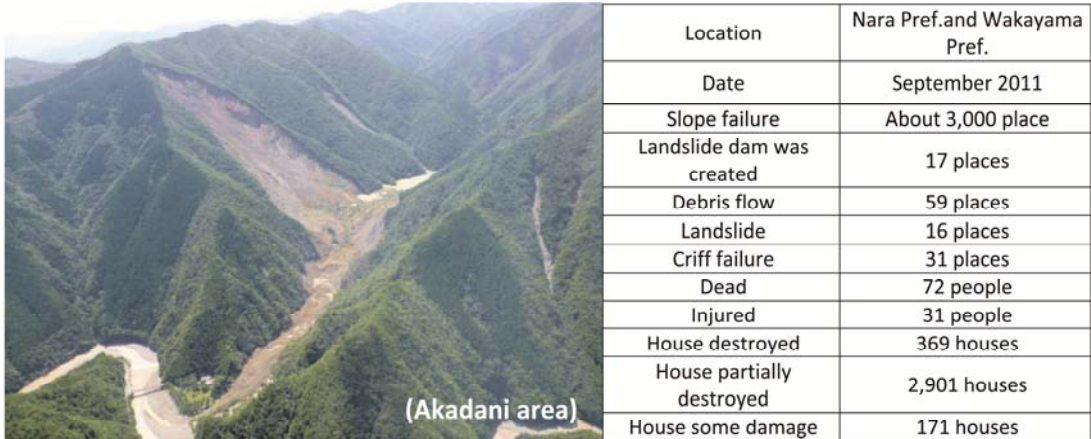
Figure 2: Overview of sediment-related disaster in Kii Peninsula, and Period rainfall distribution (August 30~September 5)

Recently, typhoons, earthquakes, and volcanic eruptions have increased in scale. In addition, the frequency of localized torrential rain from continuously generated clouds, the so-called “back-building phenomenon”, has increased. This has led to large-scale sediment-related disasters, such as those observed in the Niigata Prefecture Chuetsu Earthquake (2004; Fig. 1) and extensive sediment-related disasters in the Kii Peninsula (2011, Fig. 2) and Hiroshima (2014; Fig. 3). Consequently, appropriate countermeasures are required to ensure regional safety.

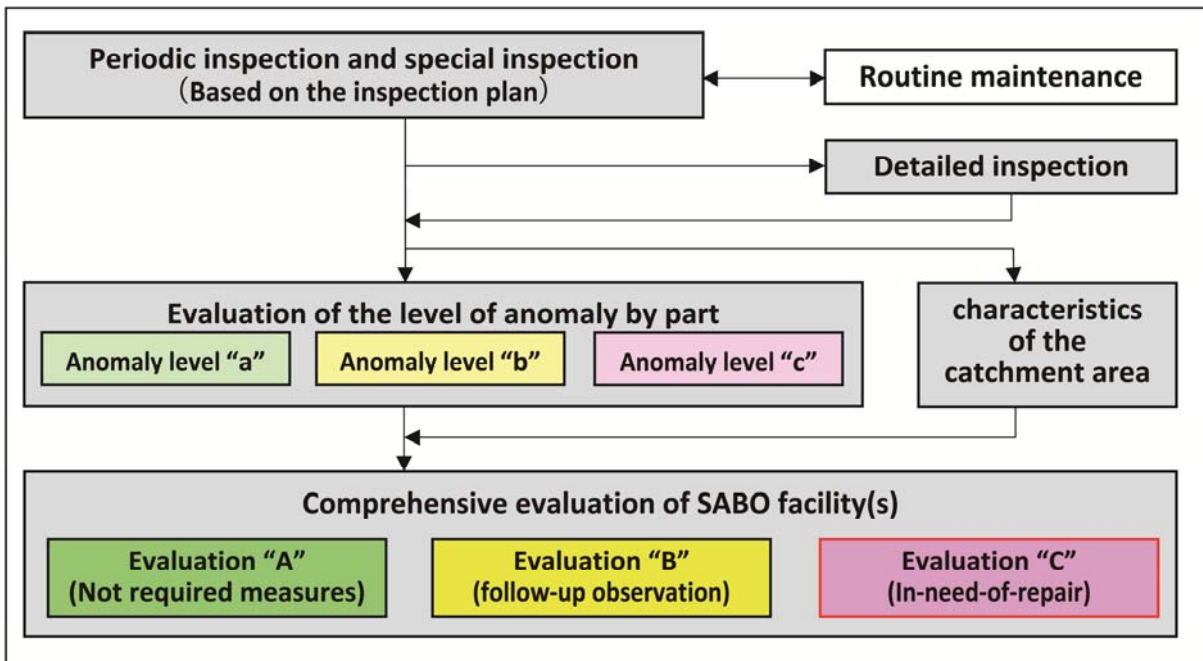
Figure 6: Comprehensive evaluation of SABO facilities

In addition to quantitative information on anomalies detected in the evaluation, factors that may cause damage or deterioration to the facility (such as the structure, material, model or characteristics of the catchment area) are observed, evaluated, or analyzed (Fig. 5). The overall soundness of the facility is evaluated comprehensively based on all this information (Fig. 6).

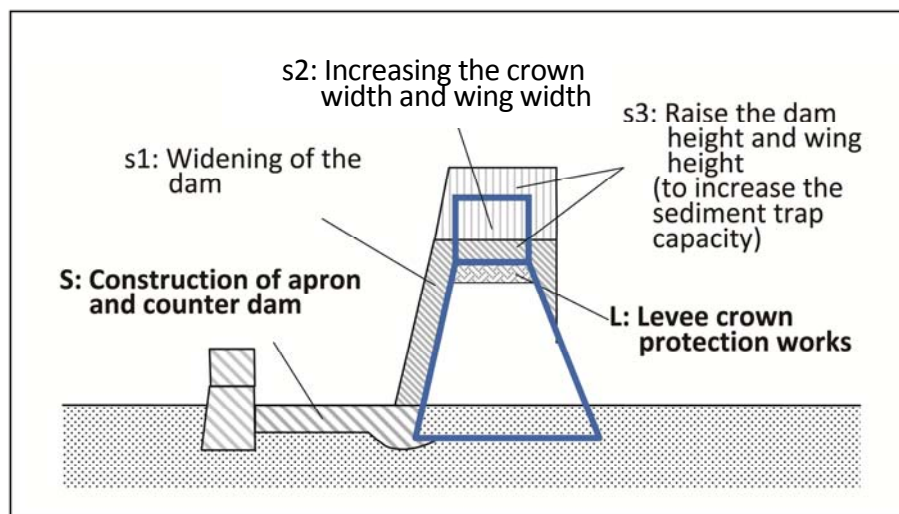
Figure 8: Example of measures in light of Maintenance and Lifespan-keeping of SABO facilities (reduction of total cost)

SABO facilities are being repaired to maintain their functions. In addition, their structures are being reinforced and function improved to achieve effective utilization of facilities from the viewpoint of maintenance and prolonging the lifespan of SABO facilities (a reduction of total cost) (Fig. 8).

For example, when a SABO facility suffers from repeated abrasion of the levee crown, it is repaired with granolithic concrete to reduce the repair frequency (L). When an apron and counter dam are constructed to prevent scouring at the foundation (S), appropriate measures are taken using a variety of actions, including widening the dam to improve stability (s1), increasing the crown and wing widths to confer greater protection against debris flow (s2), and raising the dam height to increase the sediment trap capacity of the SABO facility (s3).
